DEPARTMENT OF TRANSPORTATION**DIVISION OF ENGINEERING SERVICES**

Contract #: 04-0120F4Cty: SF/Ala Rte: 80 PM: 13.2/13.9File #: 69.28**WELDING INSPECTION REPORT****Resident Engineer:** Siegenthaler, Peter**Address:** 333 Burma Road**City:** Oakland, CA 94607**Report No:** WIR-017507**Date Inspected:** 26-Sep-2010**Project Name:** SAS Superstructure**OSM Arrival Time:** 1900**Prime Contractor:** American Bridge/Fluor Enterprises, a JV**OSM Departure Time:** 700**Contractor:** Zhenhua Port Machinery Company, Ltd (ZPMC), Changxing Island **Location:** Shanghai, China**CWI Name:** See below**CWI Present:** Yes No**Inspected CWI report:** Yes No N/A**Rod Oven in Use:** Yes No N/A**Electrode to specification:** Yes No N/A**Weld Procedures Followed:** Yes No N/A**Qualified Welders:** Yes No N/A**Verified Joint Fit-up:** Yes No N/A**Approved Drawings:** Yes No N/A**Approved WPS:** Yes No N/A**Delayed / Cancelled:** Yes No N/A**Bridge No:** 34-0006**Component:** Tower and OBG Components**Summary of Items Observed:**

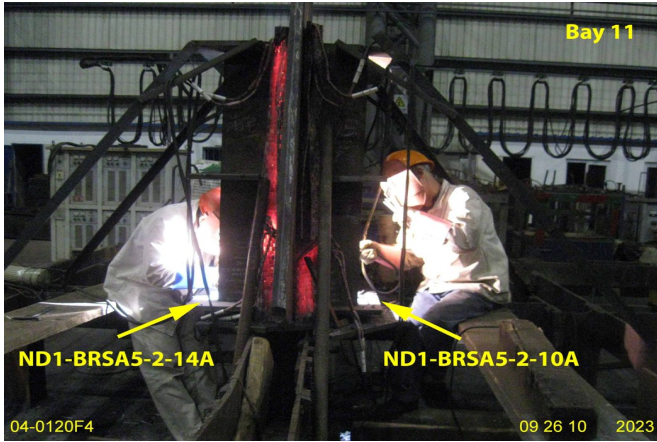
SMAW welding of weld joints ND1-BRSA5-2-10A, ND1-BRSA5-2-14A located on PCMK ND1-BRSA5-2. Welders were identified, respectively, as 044541, 054460. QC was identified as QC1. Welding variables recorded by QC1 appeared to comply with WPS-B-T-3213-TC-U4b. See photo below.
